**5.0 DESCRIPTION AND EVALUATION**  
**THOMAS JAMES HOUSE**

## **5.0 DESCRIPTION AND EVALUATION OF THOMAS JAMES HOUSE**

The expanded APE includes one 50-year-old resource: the Thomas James House (CRS No. K-2686), which was previously surveyed in 1980. The property was not evaluated as part of the 1980 survey.

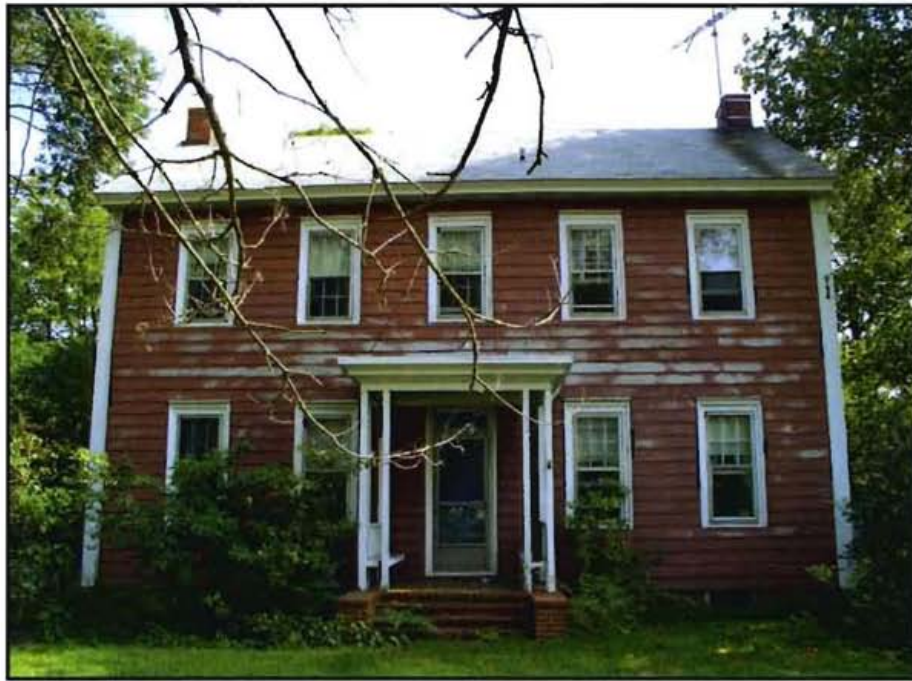
**Photograph 5:** K-2686, Thomas James House: West elevation, view to northeast. Note original windows and replacement porch (September 2007).

The dwelling faces west towards Clapham Road. A simple wood entry porch, centrally located on the facade, features brick steps, landing, and simple wood posts. The entry porch replaced a previous wood entry porch with filigreed brackets documented on the 1980 survey form. A carpenter-gothic, wood bench is located on the north and south sides of the porch and spans between the porch posts and facade of the dwelling. Between 1980 and 2007, a pedimented entry porch was added to the secondary entry centrally located on the south elevation of the rear ell. The porch consists of brick steps, landing, and aluminum railing, posts, and balustrade.

The dwelling features six-over-six light, double-hung sash, wood windows on the west and east elevations of the front block. The north and south elevations contain two evenly spaced, four-over-four light, double-hung sash, wood windows in the gables. The south and north elevations of the rear ell contain six-over-six light, double-hung sash, wood windows in the first story. The first story of the rear ell's north elevation features aluminum, replacement windows hung in pairs. The upper story of each elevation features narrow, rectangular, double-hung sash windows, some of which have been replaced. Two evenly spaced, four-over-four light, double-hung sash, wood windows light the gable on the east elevation of the rear ell.

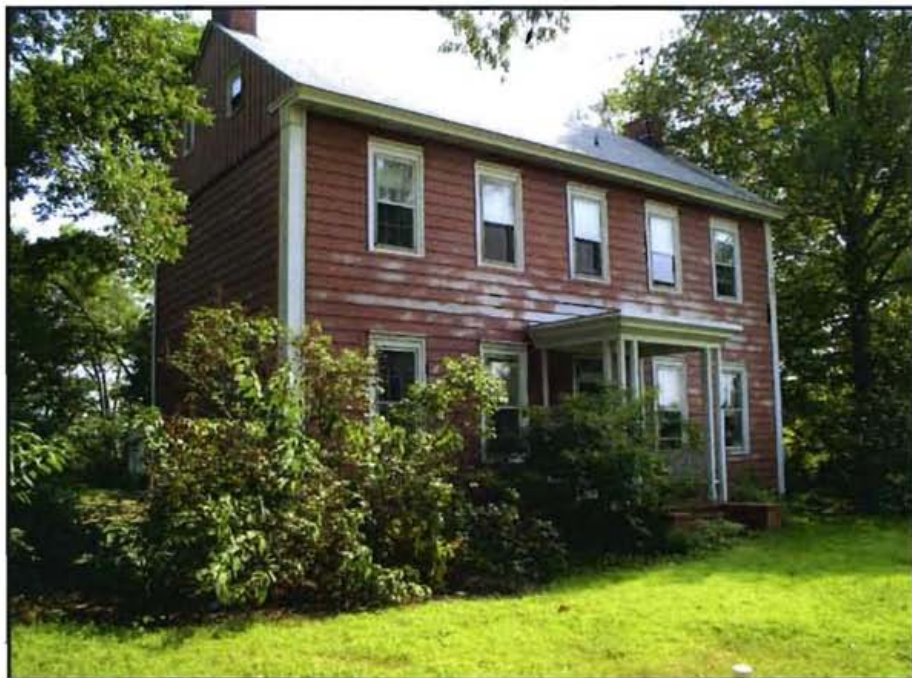
**Photograph 6:** K-2686, Thomas James House: North and west elevations, view to southeast. Note gable-end returns and corner boards associated with the Greek Revival style (September 2007).

The Thomas James House embodies elements of a mid-nineteenth-century dwelling with Greek Revival detailing, including symmetrical facade, paneled door with transom, corner boards, and gable end returns. It retains integrity from its initial period of construction (ca. 1820) and *circa*-1850 addition. Therefore, the property is recommended eligible under National Register Criterion C.

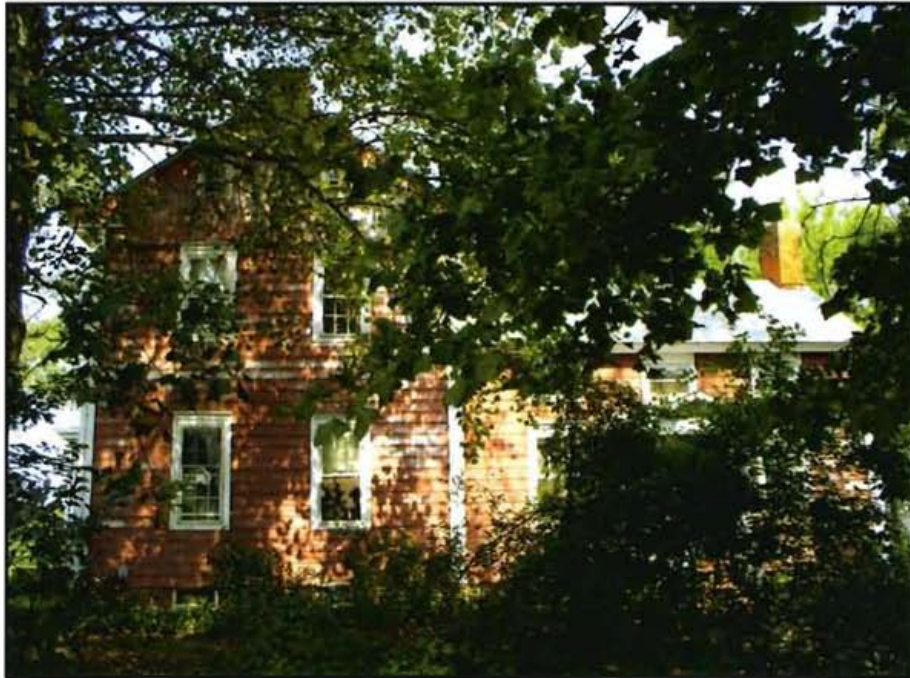
**Photograph 7:** K-2686, Thomas James House: South elevation, view to north. Note retention of massing (September 2007).

The Thomas James House retains the majority of the aspects of integrity enabling it to convey its architectural significance. Integrity of design is most critical when evaluating individual resources as representative examples of a type under Criterion C. The reconstruction of the front porch and small scale additions to the rear ell do not compromise the integrity of design of the dwelling as it retains its L-shaped footprint, fenestration pattern, massing, chimneys, and roofline.

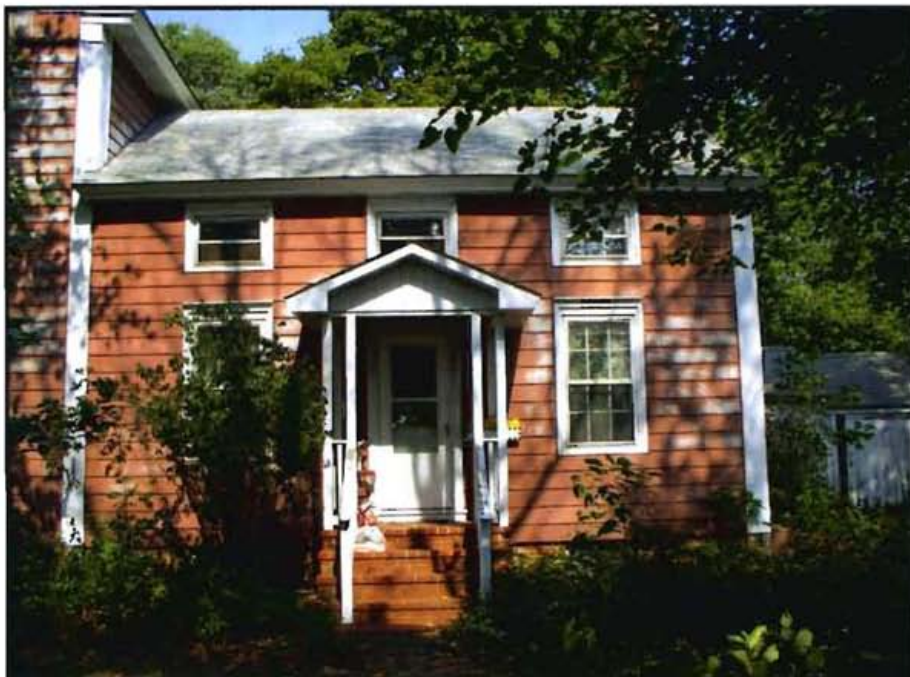
**Photograph 8:** K-2686, Thomas James House: South elevation of rear ell, view to north. Note replacement windows in upper half story and replacement porch (September 2007).

The material integrity of the dwelling has been somewhat compromised by the cladding of the roof in asphalt shingles, the encasement of the exterior in aluminum siding, and the replacement of some doors and windows. However, the Thomas James House retains most of those physical elements of construction including brick foundation, brick chimneys, majority of original windows with wooden sills, paneled entrance door, and transom. Integrity of workmanship is evident in the brick foundation, chimneys, entry benches, and wood sills. Based on an examination of historic aerials and mapping, the dwelling appears to retain integrity of location, as it is located adjacent to the roadway and gravel farm lane. The integrity of setting has been somewhat compromised by the

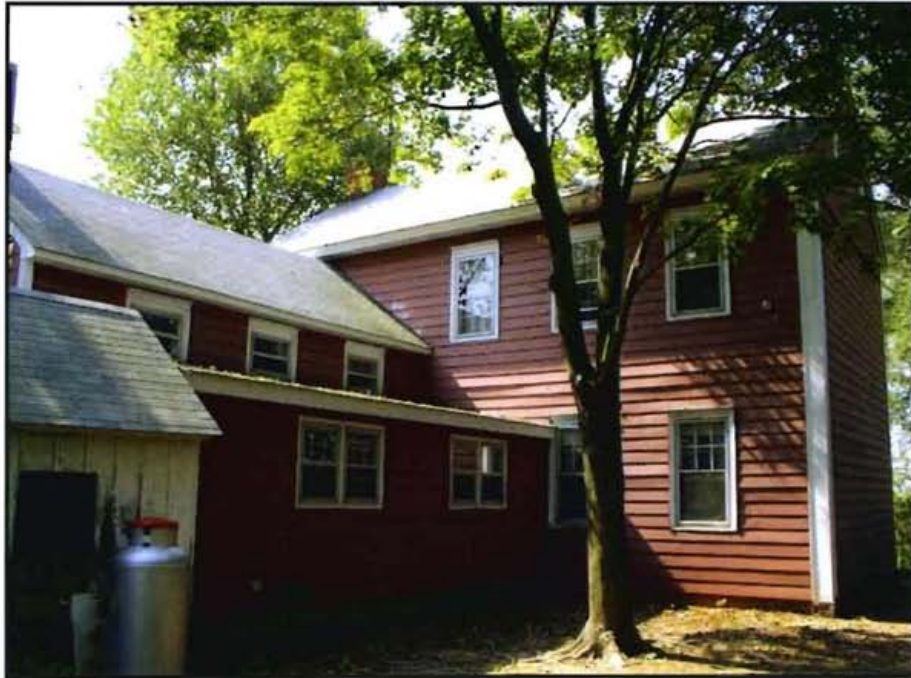
**Photograph 9:** K-2686, Thomas James House: North and east elevations, view to southeast (September 2007).

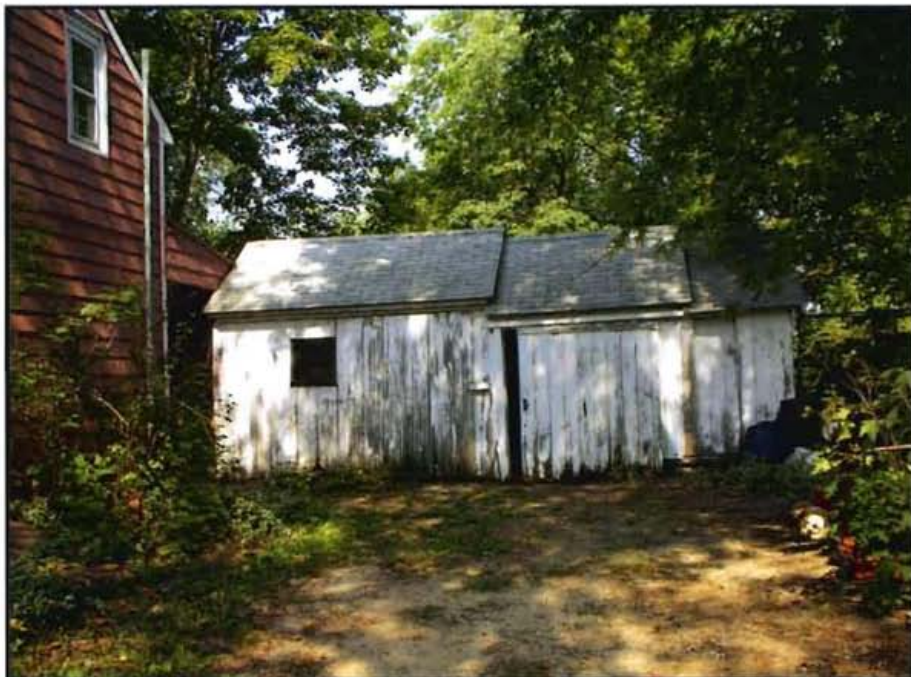
**Photograph 10:** K-2686, Thomas James House: Former tool/wood shed, south elevation, view to north (September 2007).

A one-story, frame, *circa*-1930 tool/wood shed, erected in three parts, is located immediately to the east of the dwelling. The building was converted for use as a dog kennel ca. 1965, and a wire mesh fence extends outward from the east elevation of the building. The building sits atop a concrete slab and vertical-board siding, painted white, covers the exterior walls. A steeply pitched, side gable roof, sheathed in asphalt shingles and featuring three separate planes along the ridge, caps the building.
